Belt Drive Monthly
Volume 31 • March 2011

What Are The Most Common V-Belt Drive **Installation Problems** And **How Do I Avoid Them?**

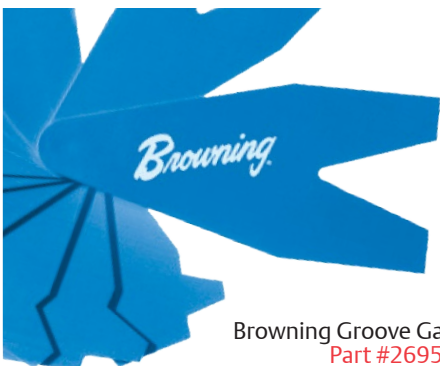
Browning Groove Gauge
Part #2695179

Habit four - Worn or damaged sheaves are an even greater cause of rapid v-belt wear, slippage and vibration. Badly worn sheaves can cause over-tensioning of the drive to prevent slippage, indirectly causing over-heated bearings and shaft damage. When only some of the grooves are worn more than others, the effect is that the belts appear to be mismatched. It also causes "differential driving" where only some of the belts are carrying the entire load of the drive. Sheaves require replacement when $\frac{1}{32}$ " or greater of wear is present. Use of a Browning groove gauge will help identify worn sheave conditions.
